Bureau of Mines Report of Investigations/1986

Calamity Hollow Mine Fire Project

5. Excavation and Evaluation of the Fire Zone

By K. E. Soroka, R. F. Chaiken, L. E. Dalverny,
and E. F. Divers

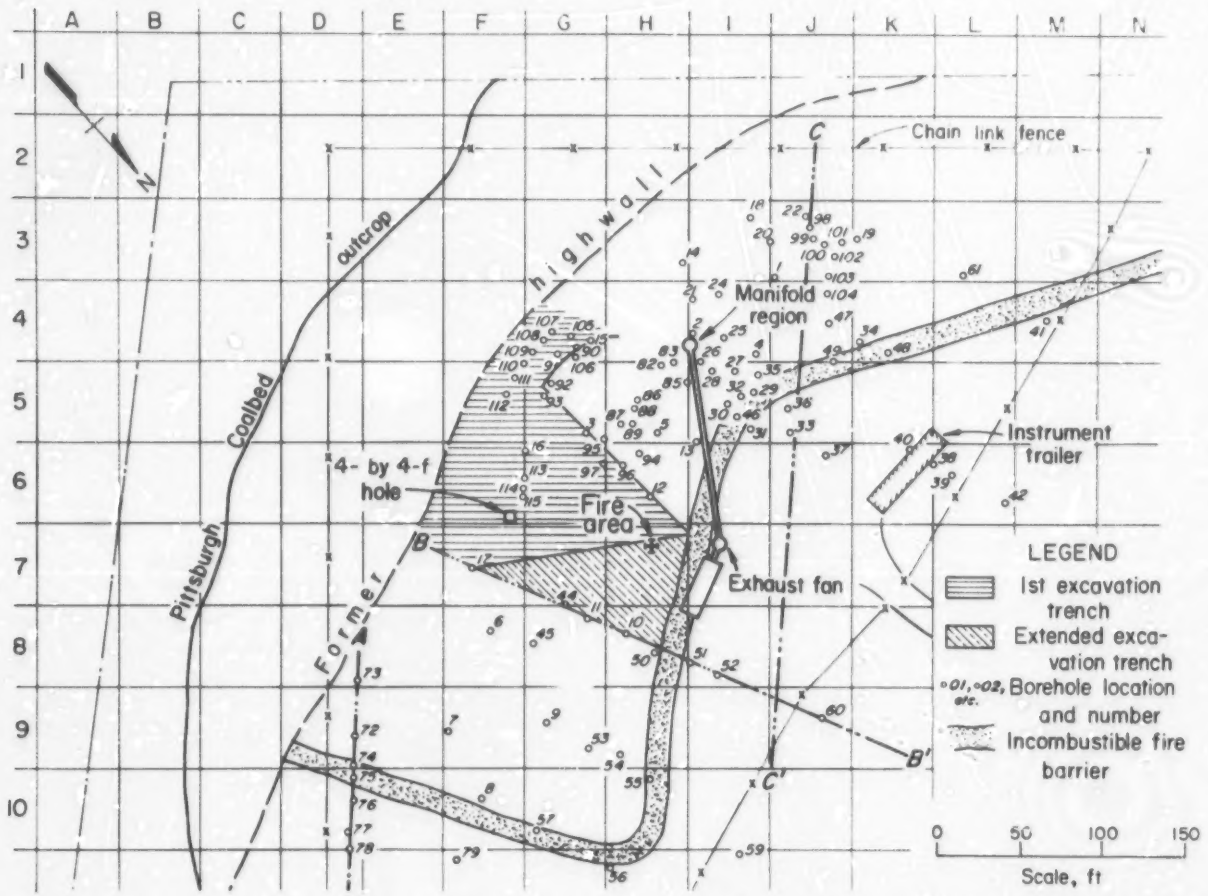
FIGURE 6. - Site plan showing first excavation trench.

The first cut of the excavation, made on June 3, 1982, was wedge-shaped with one edge along a line passing through borehole 3 (G, 5), the point at the isolation trench barrier near the dropout tank, and the other edge along a line passing through borehole 17 (F, 7) (fig. 6). The first cut was initiated in the area that incorporated borehole 15 (G, 4) and the former highwall (fig. 6). As the surface layer (15 ft) was removed to expose brownish-red strata, water vapor rose indicating that heating had occurred.

Five days into the excavation, a fire was observed near borehole 12 (H, 6) in a portion of the seam originally assumed to be on the "cold" side of the excavation trench (fig. 6). This active fire along the eastern boundary of the cut was approximately 37 ft below the surface in an

The exposed cold eastern boundary strata appeared as normal brown earthern colors with rubblized coal in the rider and main coal seams. In contrast to the boundary, material exposed in the vicinity of boreholes 16 (G, 6), 12 (H, 6), and 113 to 115 (F-G, 6), while not uniform, showed large burned regions in rider coal seams, tops and sides of pillars, and partial, varying degrees of pillar coking. Figure 7 shows a section of a pillar from the general location of boreholes 113 to 115 (F-G, 6). The strata associated with these burned regions were red and orange with streaks of white, which appeared to be ash residue. However, even in these burned areas, the bottom 2 to 3 ft of the 5 to 7 ft high main coal seam appeared unaffected by heat.

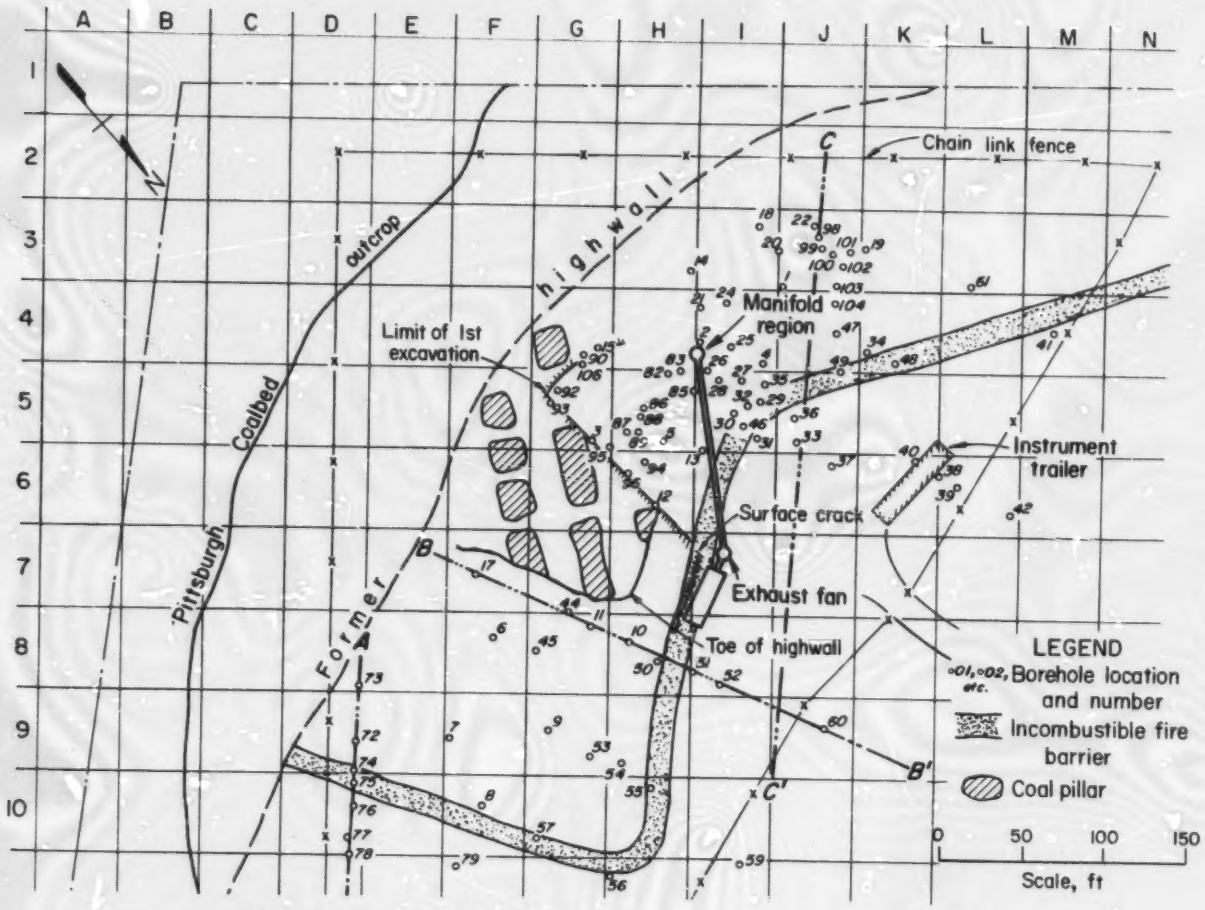
FIGURE 8. - Coal pillar orientation to incombustible fire barrier.

On June 11, the excavation had progressed to the point of removing overburden along the original isolation trench barrier below the generator (fig. 8). As the removal proceeded, a large crack appeared in the ground under the generator assembly, and water-saturated material in the barrier collapsed when undercut. The region was excavated as near to the base of the isolation trench barrier and underclay as was possible without collapsing the surface installation. No burning was detected, and we concluded that the entire northeastern region of the burn zone had been isolated and would present no further threat of reignition. Figure 8 also shows the location of several coal pillars that appeared to have been affected by heat; i.e., color had changed to shades of red and white in the rider coal seams, and to gray and silver in the top 2 to 3 ft of the coal pillars. The exposed pillars, evaluated by the contractor to be recoverable coal were removed from the site.

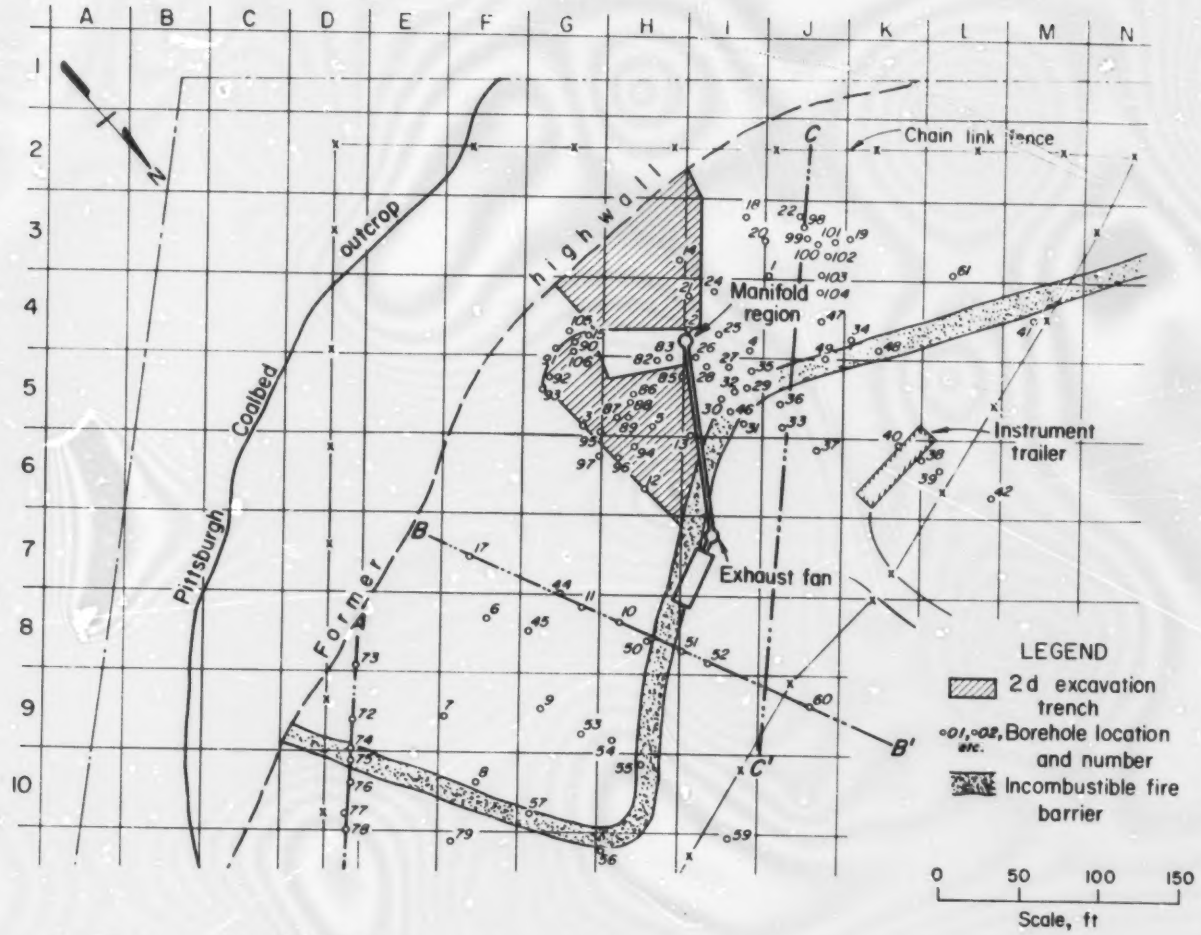
FIGURE 9. - Site plan showing second excavation trench.

On June 14, a second cut was initiated to excavate the region along the exhaust manifold which included boreholes 14 (H, 3), 21 (I, 4), and 2 (I, 4), shown in figure 9. The strata, in all shades of orange and red in the vicinity of the exhaust manifold, were very warm, dry, and highly fractured. Although no temperatures were recorded, puddled water was observed to boil in this area. When the manifold was exposed, the subsurface fractures were seen connecting to the surface fractures that had been observed during the burnout operation. Figure 10 shows the exposed exhaust manifold. Figure 11 shows the nearly straight wall along the manifold with the uppermost rider coal seam exhibiting the most color changes. Shades of orange, red, and white are contrasted to earthen shades (browns) above and below the rider seams, showing a line of combustion along these seams to the base of the exhaust manifold. Figure 12 provides a view of the base of the manifold positioned a few feet above the rider seam. During the burnout, clinkers, which are stony matter fused together at temperatures probably in excess of 1,200° C (2,192° F), formed at the base of the manifold. Figure 13 shows several clinkers removed from the area directly below the manifold (fig. 12).

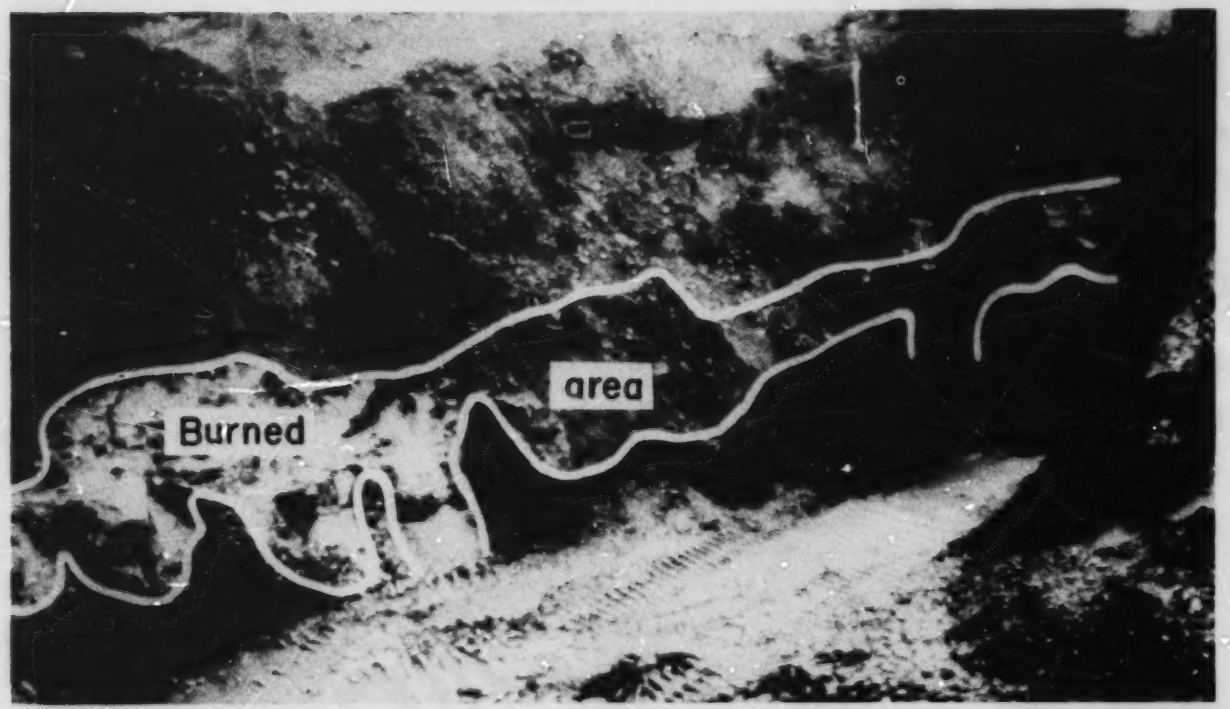
FIGURE 11. - Rider coal seams showing combustion line along seams to base of exhaust manifold.

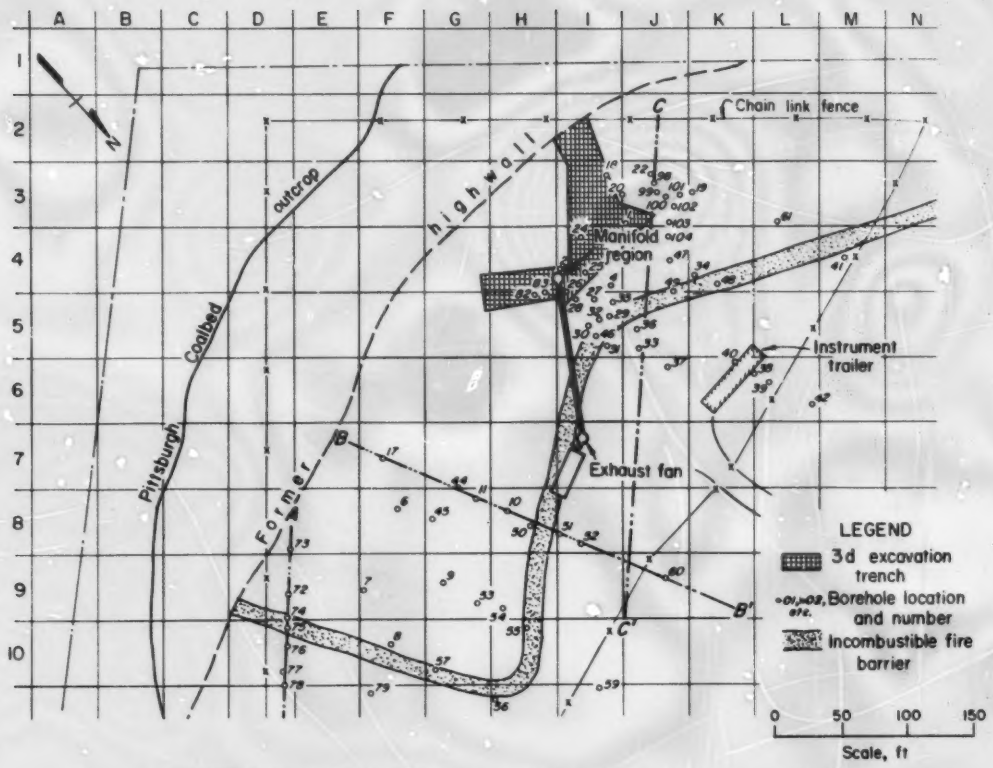
FIGURE 14. - Site plan showing third excavation trench.

The ventilation system was disassembled as the third excavation trench was dug (fig. 14). Excavation of this area provided the same observations as the first two areas: Rider coal seams were burned with red dog appearing above and below each rider coal seam, some areas of white ash were apparent, pillars were burned along the edges, and entries were caved showing small voids in the strata. Actual fire movement was not traceable, but the presence of fire was evident through

measured strata temperatures. After removing 25 to 30 ft of overburden in the area, including boreholes numbered in the eighties (H, 5), the temperature measured approximately 200° C (392° F). Excavation exposed a pillar devolatilized to within 1 ft of its base. The pillar was located below boreholes 94, 96, 95, and 87 (G-H, 6) (fig. 6). The temperatures measured in all these boreholes were greater than 200° C (392° F) at the termination of the burnout.

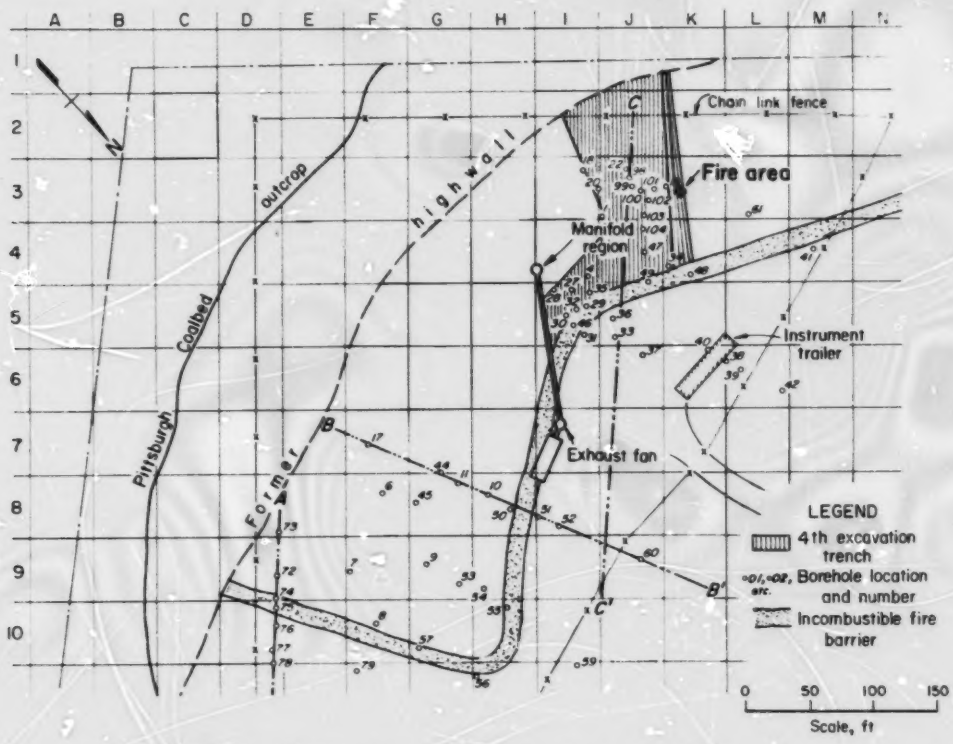
FIGURE 15. - Site plan showing fourth excavation trench.

In the fourth excavation area, the incombustible fire barrier that isolated the fire zone from the "cold" side of the mine was very moist with a temperature of 50° C (122° F). On the fire-zone side of the barrier, the temperature in the underclay at the base of the barrier was 36.8° C (98.2° F). All observations supported the conclusion that fire had not breached the original incombustible fire barrier.

As the final trench was excavated toward the western field, a fire was discovered near borehole 19 (K, 3) (fig. 15). Flames, visible through voids in the strata, were quenched with water.

This burning area was also beyond the perimeter of water penetration from the quenching phase of the project. Continued excavation at this site exposed a pillar that appeared to be thoroughly coked. The temperature of the removed rubble was greater than 258° C (496° F), indicating relatively recent combustion.

The fourth excavation trench exposed (1) areas of red dog with average strata temperatures of 160° C (320° F), (2) areas of strata with colors ranging from light orange to bright red, (3) areas of partial coking resulting from exposure to a range of temperatures, (4) areas of ash streaks throughout the burned rider seams, and (5) intact solid coal pillars. On June 7, the extended western excavation boundary exposed a burned coal pillar on the west wall near the outcrop, but the measured temperature in the burned area was only 25° C (77° F) with the ambient air temperature recorded as 31° C (88° F). The low temperatures and lack of combustion odors indicated that fire had occurred in this area years ago and that enough time had elapsed for the residual heat to have completely dissipated. It was evident that no active fire remained on site. The backfilling was then completed with recontouring and grass seeding. Figure 16 is a view of the site several months after completion of this project.

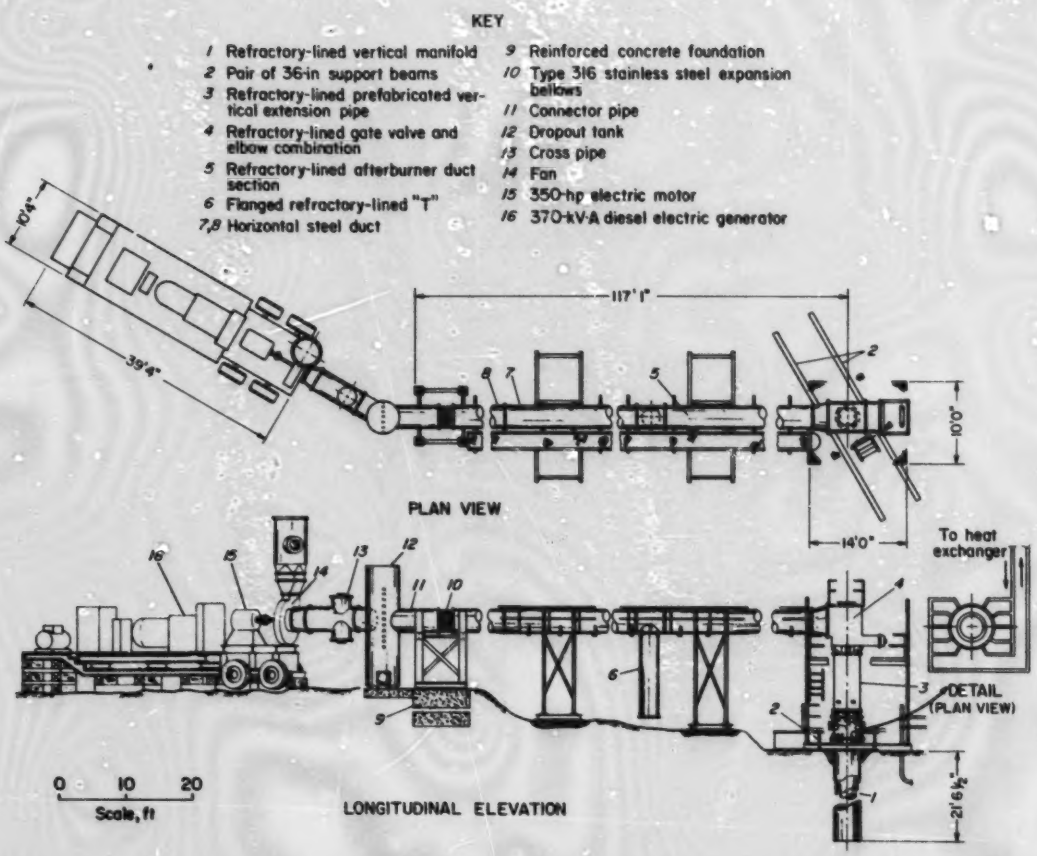
FIGURE 17. - Burnout unit assembly.

Dismantling the Burnout Control system offered a good opportunity to evaluate how various components and probes survived exposure to extreme temperatures and corrosive combustion products such as moisture and sulfur dioxide. The assembled components of the ventilation system are shown in figure 17. The reader is referred to part 1 (2) and part 3 (11) of this report series for detailed descriptions of the components.

The flanged T-section was most affected by the operation. The combined flow of ambient air, hot moist gas and water spray resulted in attrition of the refractory brick lining of the T-section abutting the unlined duct (fig. 19).

One area of erosion was the air inlet T-section (figs. 17, 19) where attrition was caused by the combined effects of hot gases, cool air, and cold water spray flowing through this section. Redesign of the water spray coolant system could include a fluid-cooled duct with internal horizontal and vertical baffles to provide better mixing of the hot gases and cold air.

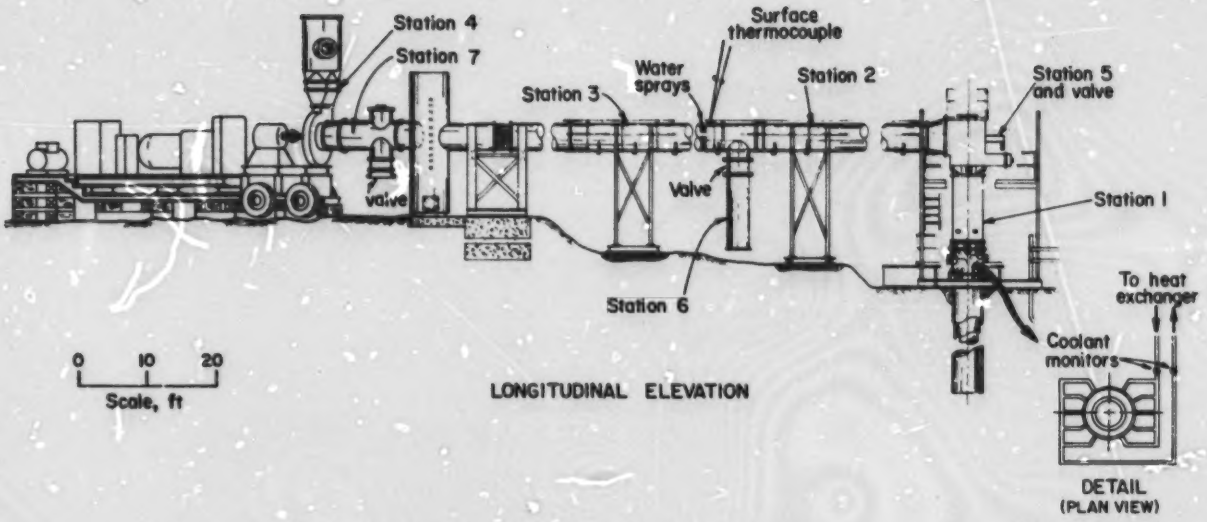
FIGURE 20. - Instrument station locations.

Figure 20 shows the location of the seven major instrumented monitoring stations on the burnout ventilation assembly. The measurements at the various stations were based on the required information for process control and for air pollutant analysis. Instrumentation included gas-sampling probes and gas-transport tubing to the instrument trailer; thermocouples cased in either alumina thermowells or stainless steel thermowells; and two types of flow-monitoring probes, which were Annubar[6] concentric-tube probes and bidirectional flow probes.

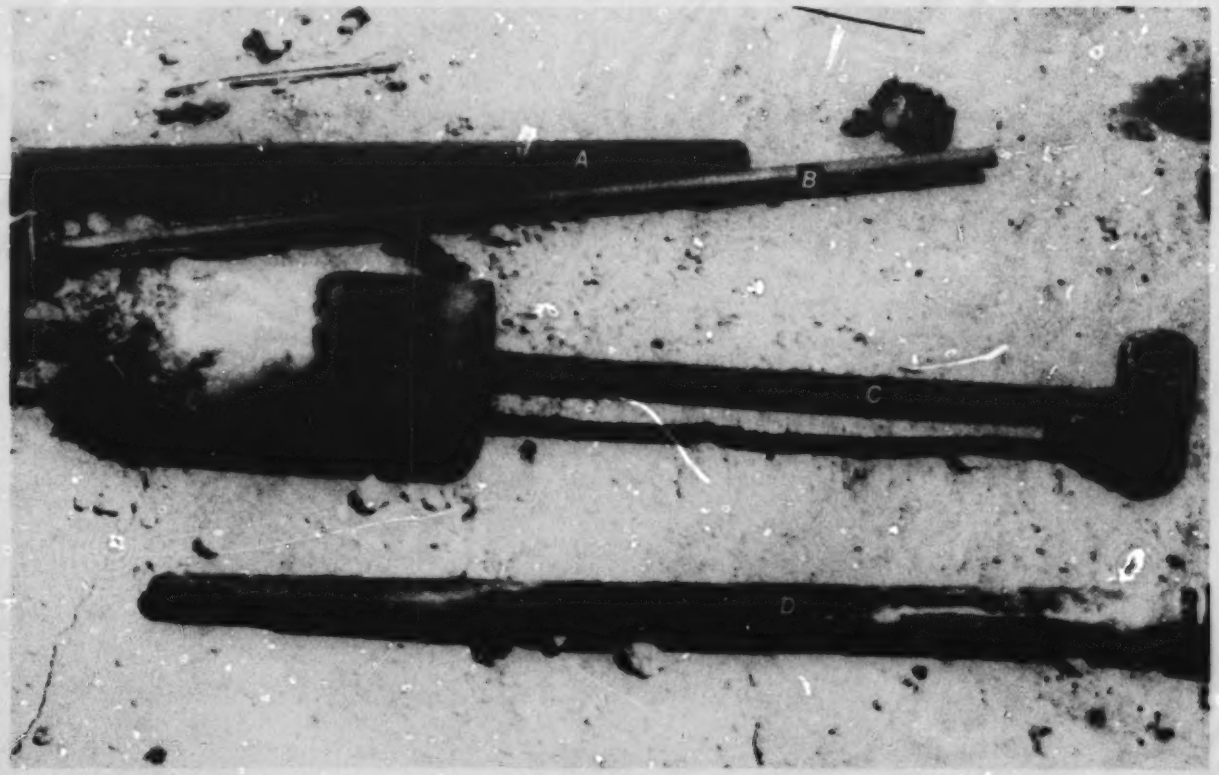
Figure 21 shows several probes removed from stations 1 and 2. The thermowells (*A* and *D*) and gas-sampling probe (*B*) changed color from the heat exposure and accumulated residue but were not damaged. The bidirectional probe assembly (*C*) also

FIGURE 21. - Instrumentation probes from stations 1 and 2. *A*, Thermowell from station 1; *B*, gas-sampling probe; *C*, bidirectional probe; *D*, thermowell from station 2.

accumulated residue, which created partial blocking and corrosion of the stainless steel tubing; however, it continued to function satisfactorily. Overall, the monitoring probes removed from all stations had changed in color, attritioned (possibly from solid particles, water droplets, and/or flowing hot, moist gases), and were covered in greenish-black residue, but all probes functioned throughout the 4-month continuous burnout operation. Minimal damage occurred to the instrumentation-monitoring probes.

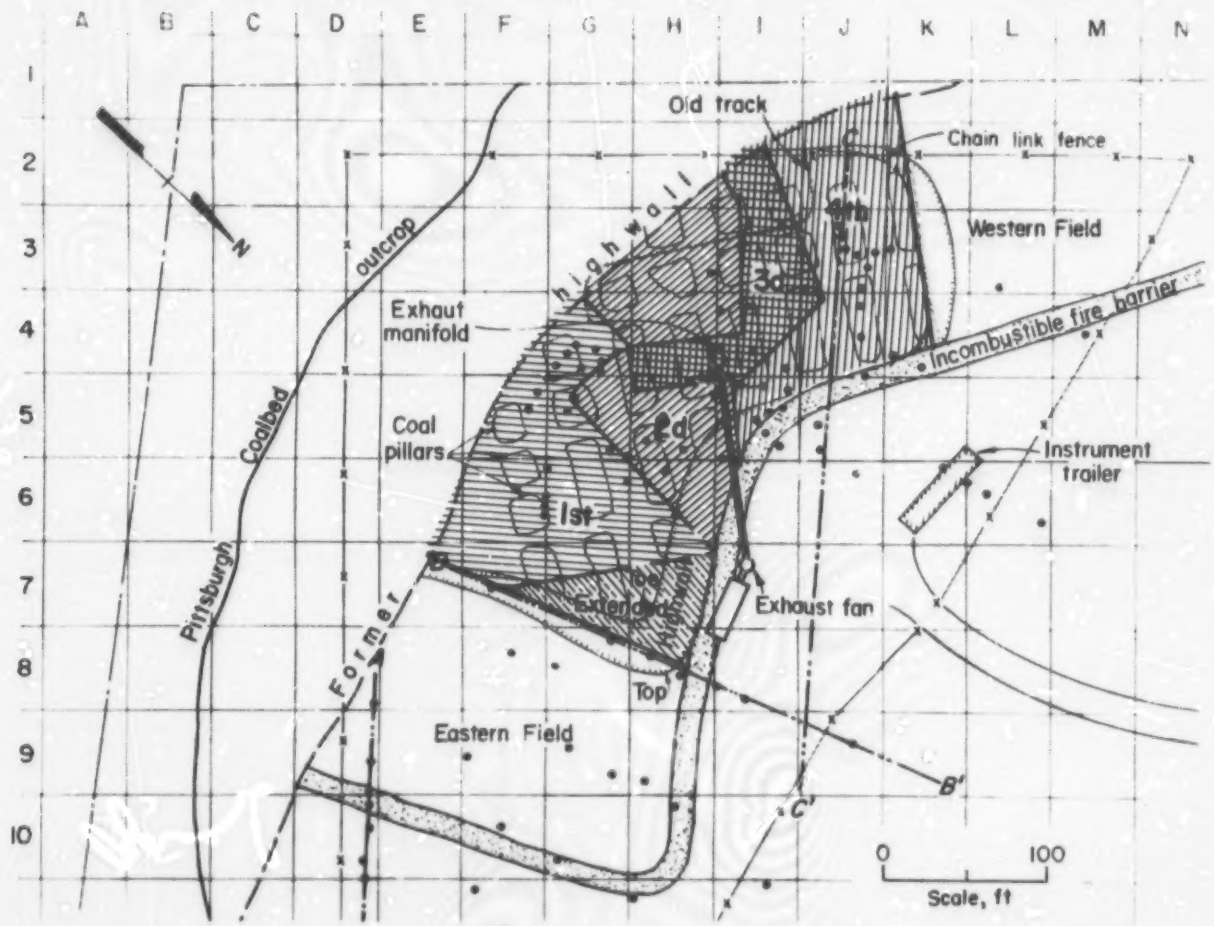
FIGURE 23. - Pillar and entry locations overlaid on borehole site plan.

At the onset of the project, it was determined that mine maps were nonexistent; however, the layout, as determined through excavation, showed pillars to be 14 to 19 ft wide and 50 to 55 ft long with entries approximately 19 ft wide. Figure 22 shows the location of the exhaust manifold and our best estimation as to the actual pillar and entry layout. From this actual layout, estimates of the coal, burned and intact, are calculated. The excavation revealed average pillar dimensions of 53 ft by 17 ft by 5 ft, implying 180 tons of coal per pillar. The average entry width was 19 ft, so the area per pillar plus entry was 2,600 ft^2 (53 ft + 19 ft) × (17 ft + 19 ft). There are 17 pillars per acre, which yields 3,000 tons of coal per acre or 5,500 tons for 1.8 acres. The original estimate of main coal seam for the 1.8 acres was 10,000 tons (2), or two times the current estimated excavated main coal seam. The original rider coal seam estimates of 6,660 tons would remain the same because we had no way of measuring the actual tonnage.

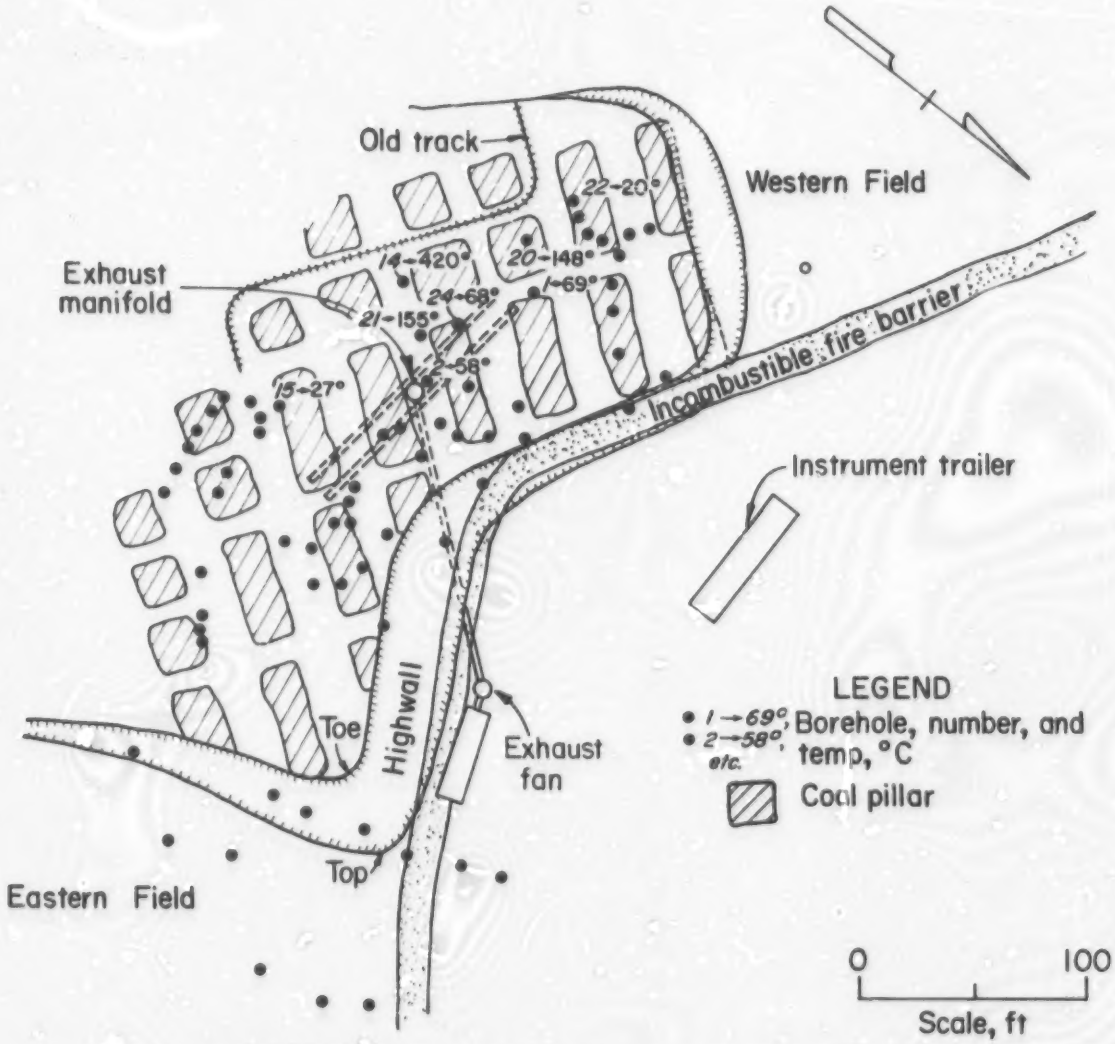
FIGURE 24. - Borehole temperatures on March 1, 1980.

As shown in figure 24, during site assessment, the temperature at borehole 14 was the highest, 420° C (780° F), with subsurface temperatures around boreholes 20 and 21 ranging from 148° to 155° C (298° to 311° F). Temperatures for boreholes 1, 2, and 24 ranged from 58° to

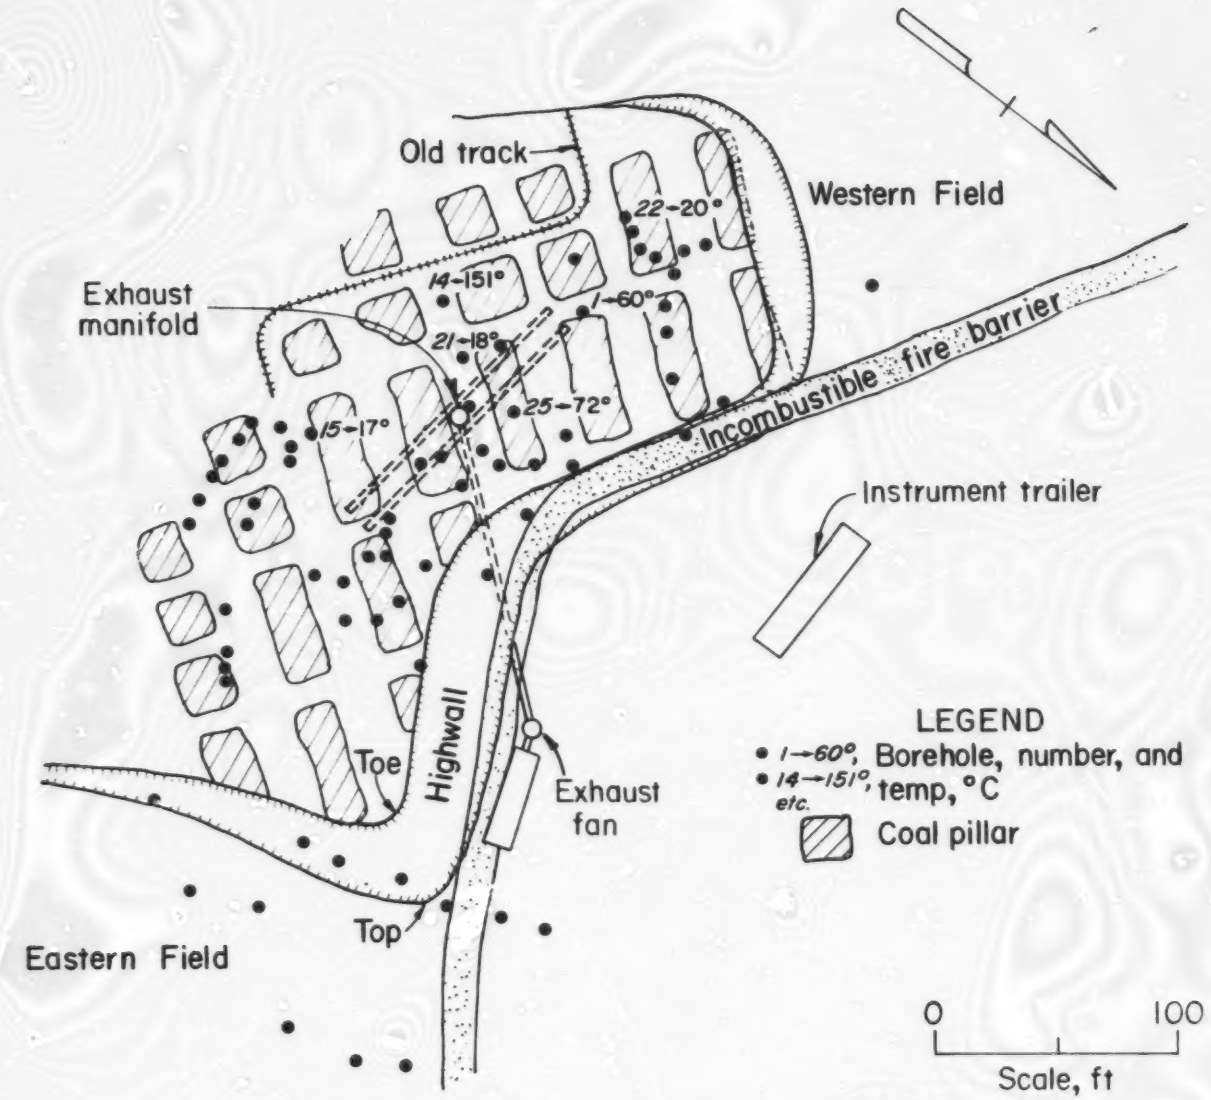
FIGURE 25. - Borehole temperatures on January 9, 1982.

The 4-month continuous operation began on January 4, 1982. Figure 25 shows the borehole temperatures recorded 5 days later. The temperature at borehole 14 had decreased to 151° C (304° F), but the temperature near the exhaust manifold increased to >200° C (>329° F). In early February, ignited charcoal was poured into boreholes in the areas of boreholes 3, 5, and 15 in order to extend the fire zone easterly to create a more uniform fire zone around the exhaust manifold.

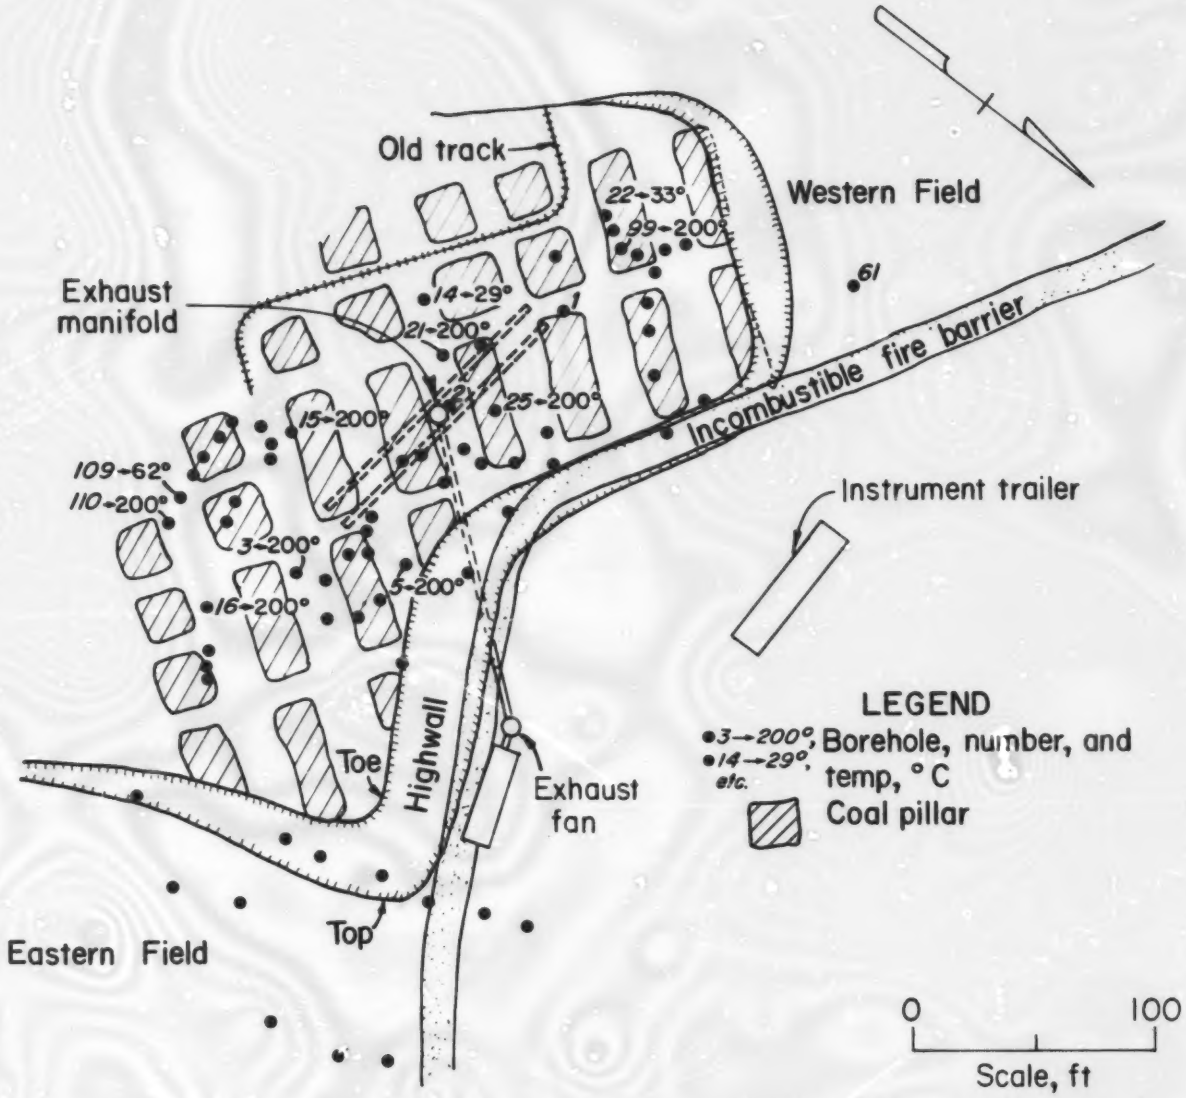
FIGURE 26. - Borehole temperatures on May 1, 1982.

On May 1, 1982, before quenching, temperatures greater than 200° C (392° F) existed from borehole 99 in the western field to borehole 16 in the eastern field (fig. 26). The progression of increased temperatures throughout the mine during the 4 months provides data supporting the acceleration of combustion as controlled by the burnout ventilation system.
